House of Hope Presbyterian Church

UTILITY INFRASTRUCTURE IMPROVEMENT PROJECT

Congregational Presentation
January 19, 2025

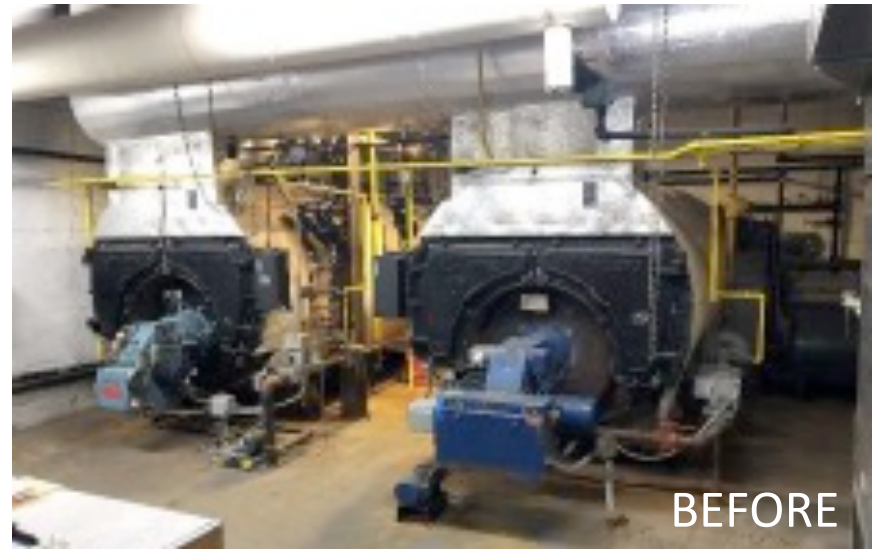
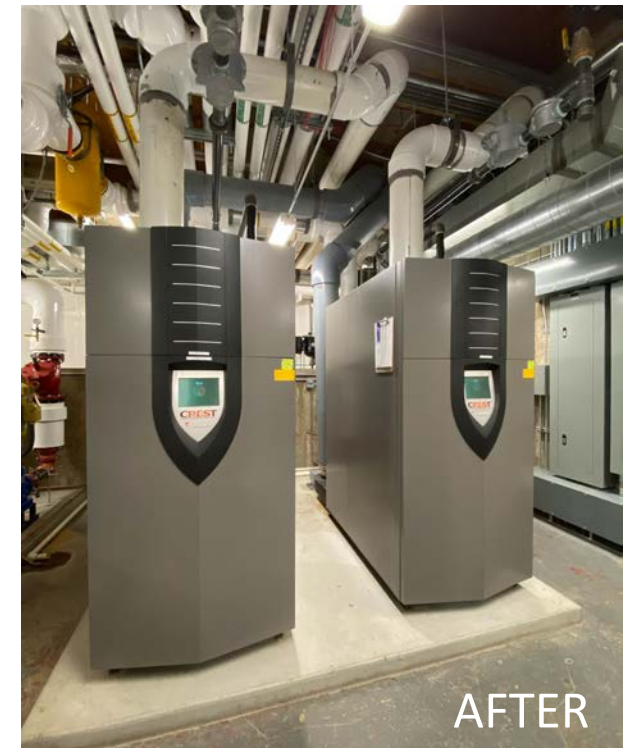
HEATING SYSTEM REPLACEMENT

- The original steam boilers and pneumatic control system were installed in 1958
- Those original steam boilers had limitations resulting in inefficient operation
 - Radiant heat loss
 - Temperature control challenges
- The new boilers are a Hydronic Heating System
 - High efficiency, condensing hot water boilers
 - Central pumping system operated by VFD's
 - New hot water piping throughout the building and new hydronic accessories
 - New digital building controls system

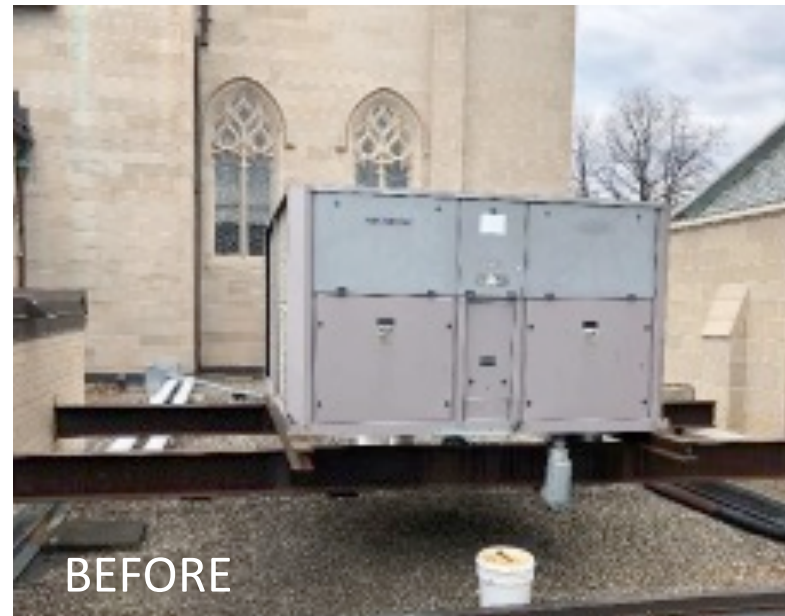
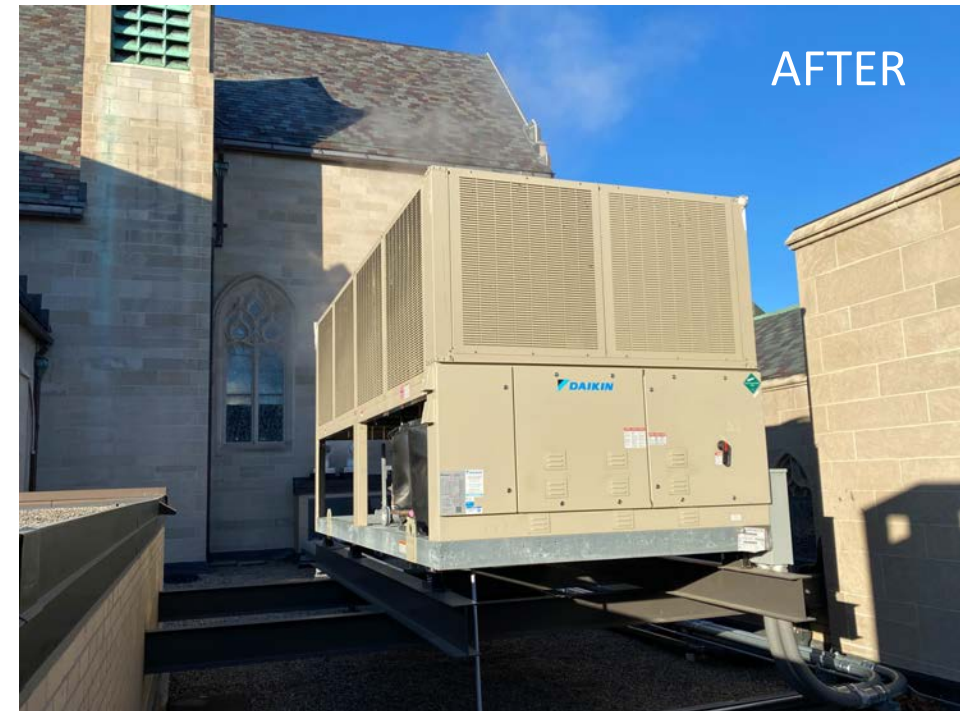
AIR CONDITIONING EQUIPMENT REPLACEMENT

- The original equipment was an air-cooled chiller mounted on the roof with 55-ton capacity and 87-ton connected load (35% diversity). It served the Sanctuary, Parlour, East Wing Education and West Wing Offices/Conference Rooms. The original equipment had no expansion capacity.
- The new equipment has 95 tons of capacity with 123 tons of connected load (25% diversity) with the additional areas of the Great Hall, Rooms A & B, the Youth Center and the Skylight Room now being served.

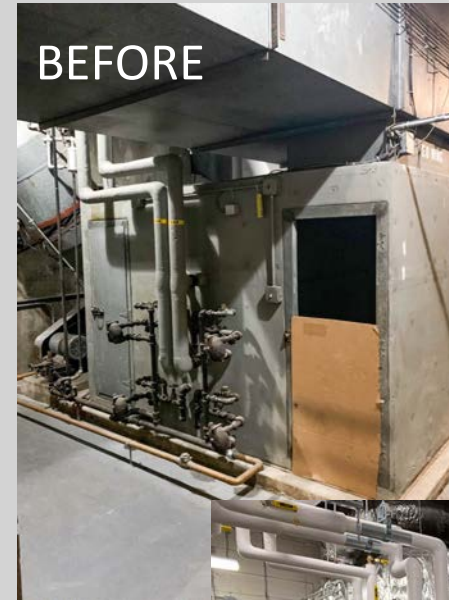
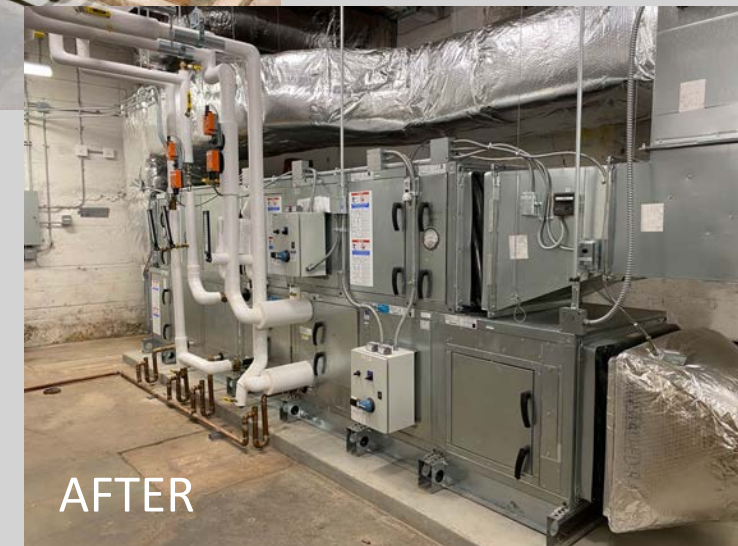
AIR HANDLERS

- Previous air handlers were all 1958 vintage with issues such as:
 - Lack of or limited return air to units
 - Improper or inadequate insulation
 - Some ductwork was undersized
 - There were some spaces without any ventilation
 - Building pressurization issues
 - Some equipment was difficult to access for maintenance
- All air handlers have been replaced with the proper type and size of unit for the area they serve
- Existing ductwork has been modified and new ductwork installed to properly serve the areas as air return via corridors is no longer allowed by code
- Air quality is better due to improvements in make-up air, return air, filtration and humidification
- Ceilings and lights in many rooms were removed to complete the work

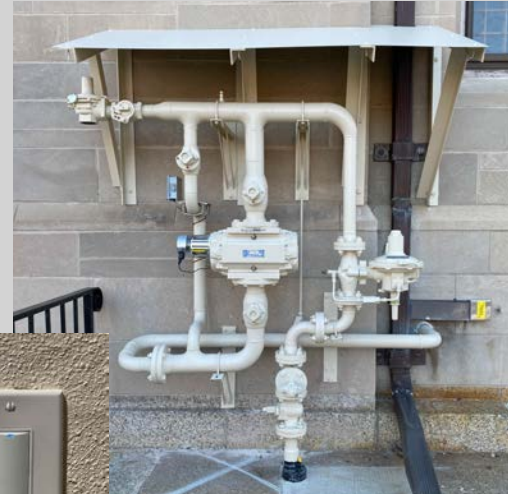
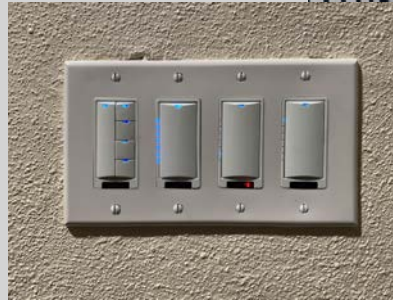
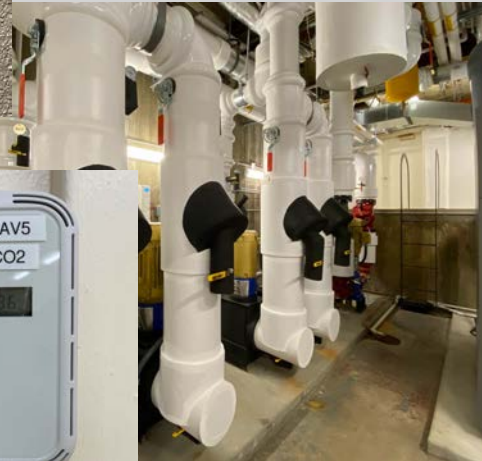
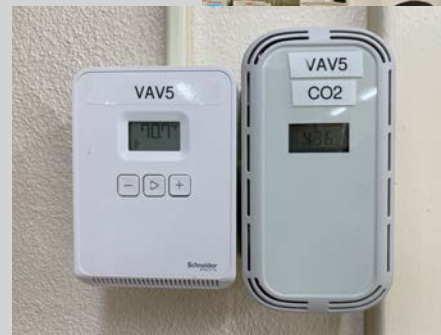
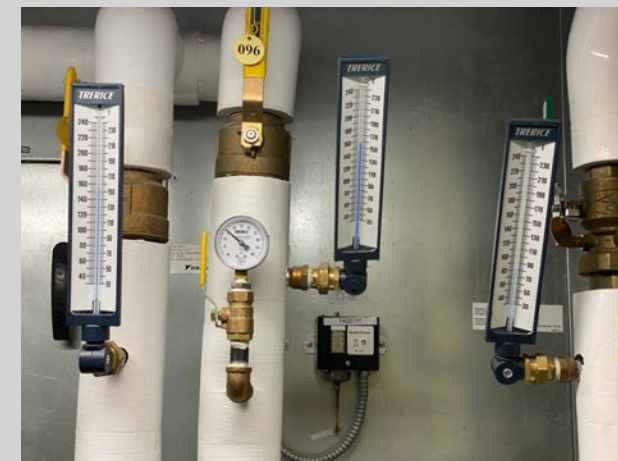
HEATING, VENTILATION AND AIR CONDITIONING (HVAC) MECHANICAL SYSTEM CHANGES

The new mechanical system includes:

- 2 Boilers
- 1 Chiller (air conditioner)
- 8 Air Handlers
- 11 Variable Air Volume Terminal Boxes
- 21 Fan Coil Units
- 3 Humidifiers
- 8 Pumps
- 2 Expansion Tanks
- 2 Air Separators
- 14 Exhaust Fans
- 59 Induction Units
- 8 Cabinet Unit Heaters
- 1 Kitchen Make-Up Air Unit
- 1 Chemical Feed system
- Direct Digital Controls System

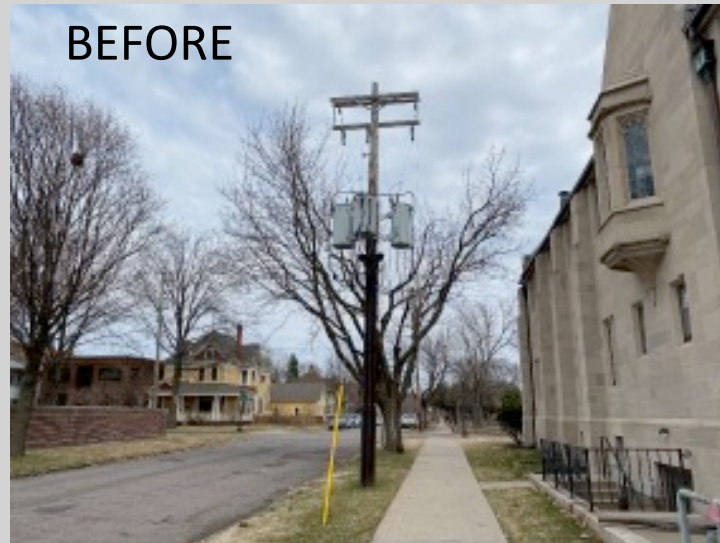
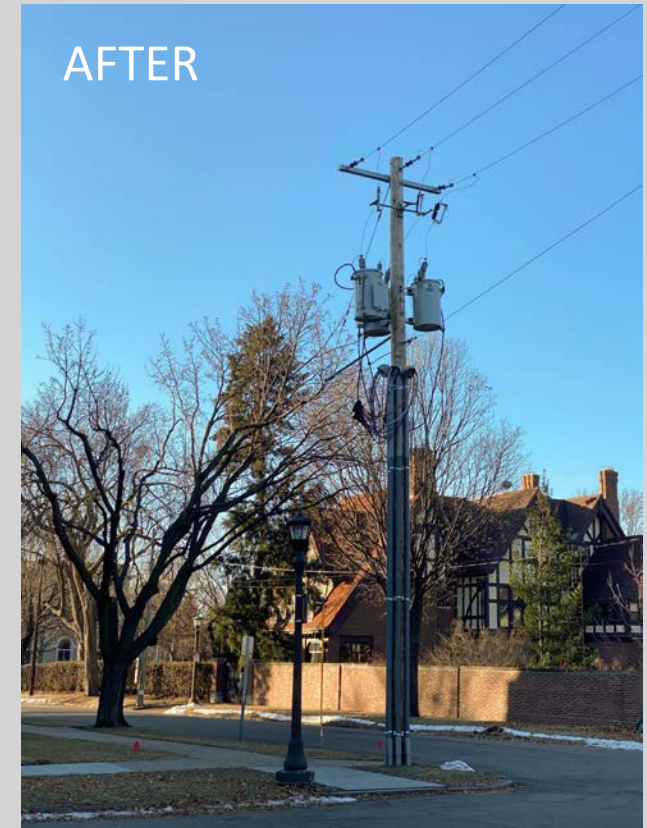
MAIN ELECTRICAL & GAS SERVICE

- The Xcel Energy service enters the building on the west side via overhead power lines and pole mounted transformers
- The original 800-amp service was insufficient to carry the new mechanical loads
- A new 1200-amp service has been installed by Xcel Energy and the project connected new feeders from the public utility service to the new main switchboard
- A new natural gas service connection was completed to the building including a new gas meter.

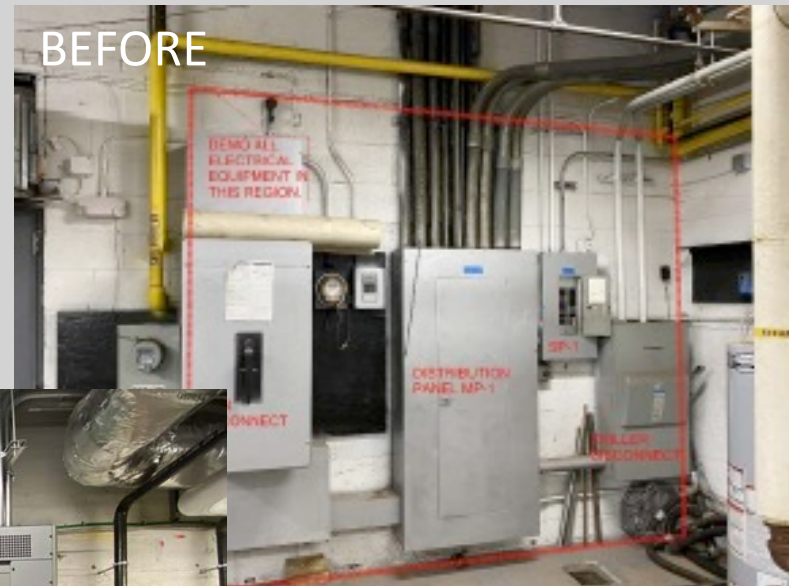
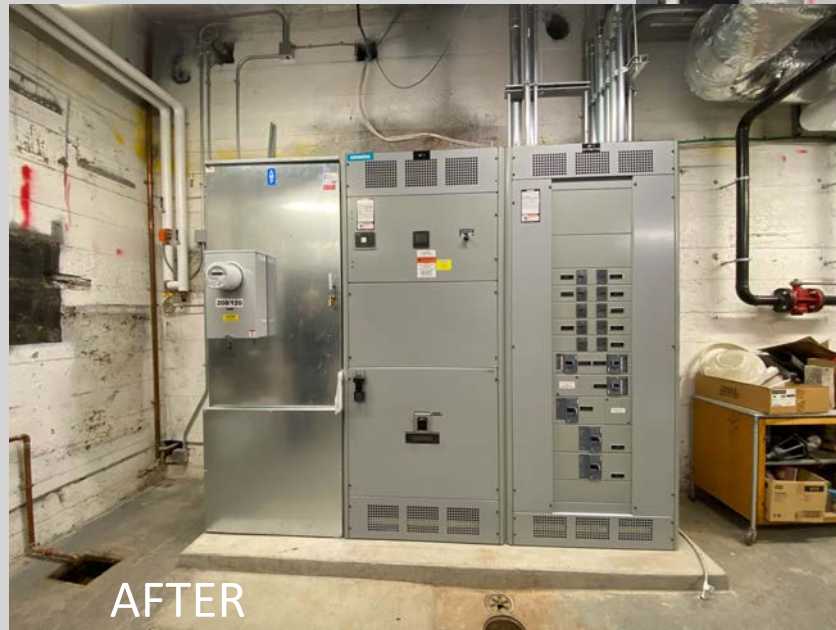
ELECTRICAL EQUIPMENT

- The original (1958) main switch and the adjacent distribution panelboard have been replaced
- The new equipment is not in the same location, but adjacent to it which allowed the electrical team to minimize the time that the church was without power during the switch of service to the new electrical gear.

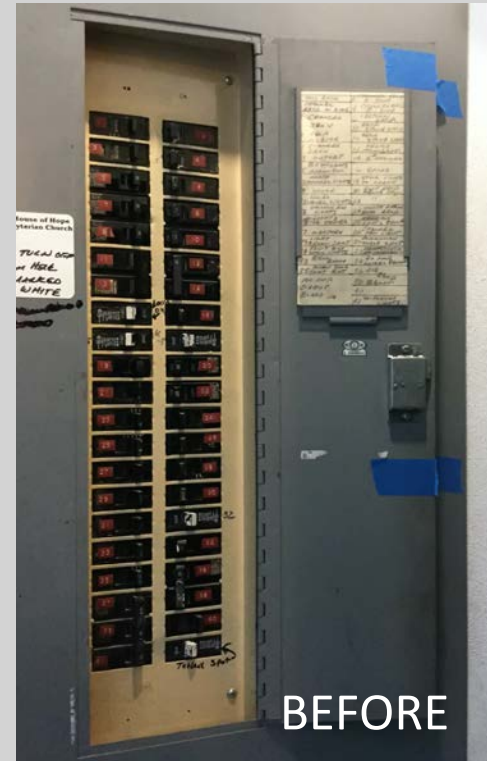
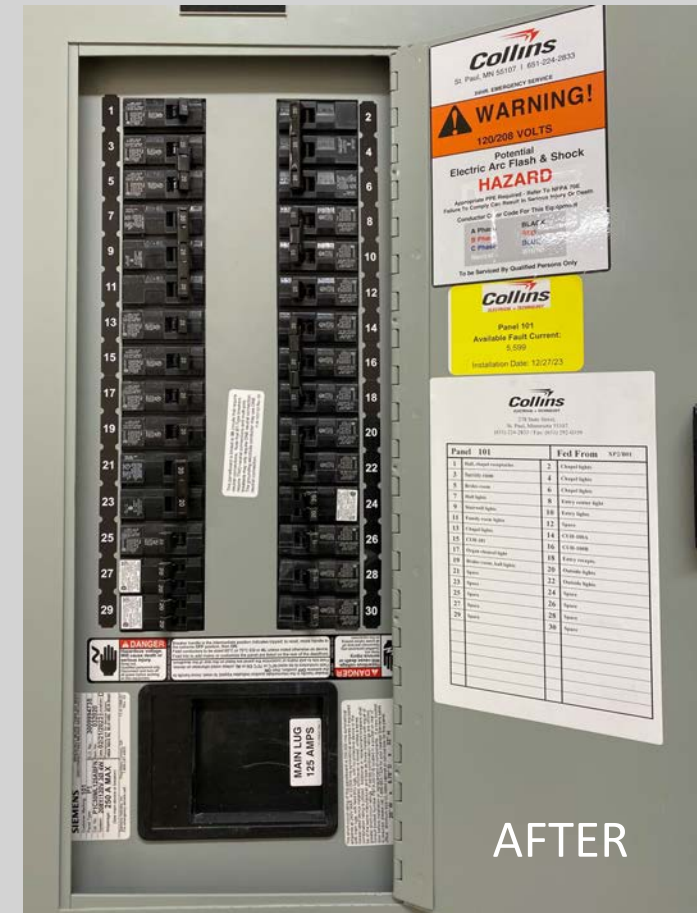
ELECTRICAL CIRCUIT BREAKER BOXES

- 21 circuit breaker boxes exist throughout the building
- The circuit breaker boxes are generally full
- Circuit breaker equipment has a typical life of 40 years. Most panels have exceeded their expected service life.
- 15 of the 21 circuit breaker boxes have been replaced – the existing enclosure and all connected conduits were kept. The panel interior and front covers have been replaced.
- The electrical feeder from the new main electrical distribution panel board to each circuit breaker box has been replaced.
- The wiring from the circuit breaker boxes to lights, outlets, etc. has not been replaced and will need to be addressed as different areas of the church are renovated over time.

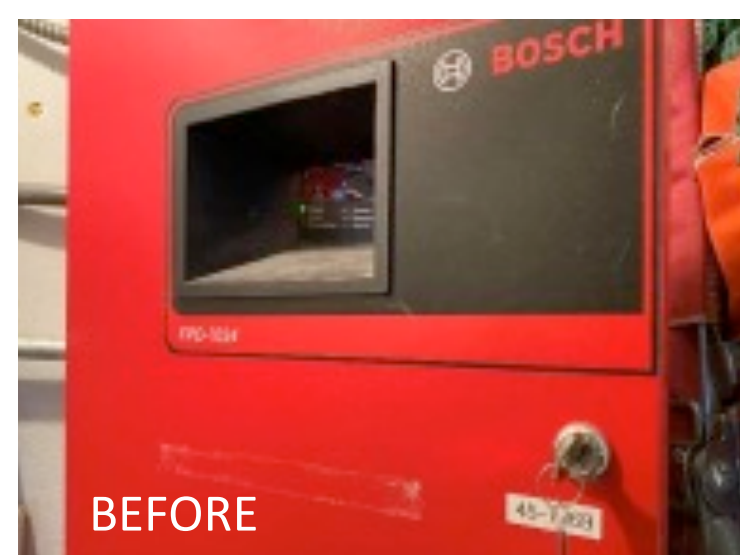
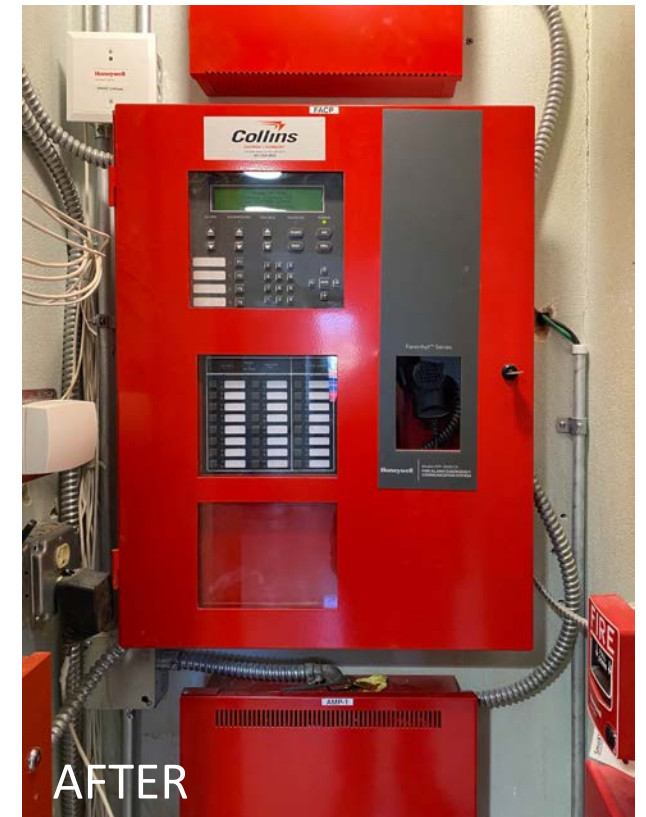
FIRE ALARM SYSTEM

- Previously the church had two separate fire alarm systems monitor the building. The two systems were networked together so an event on either system initiated a general alarm to the entire building
- The City required replacement of the previous systems with a single addressable smoke/fire notification system

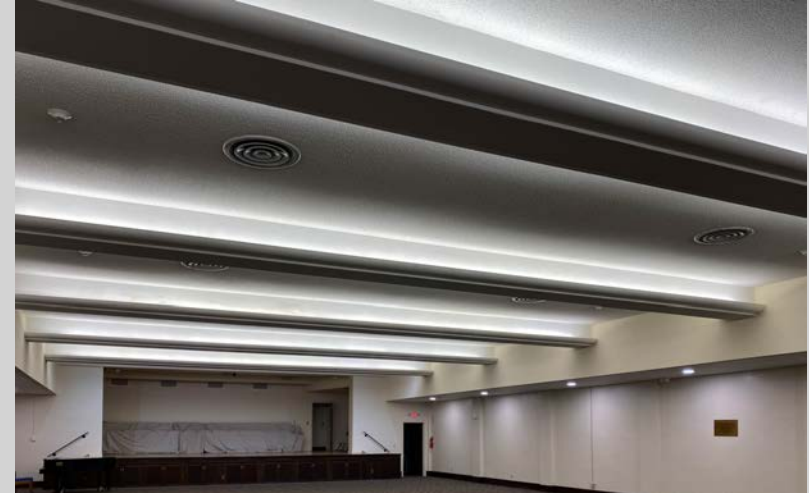
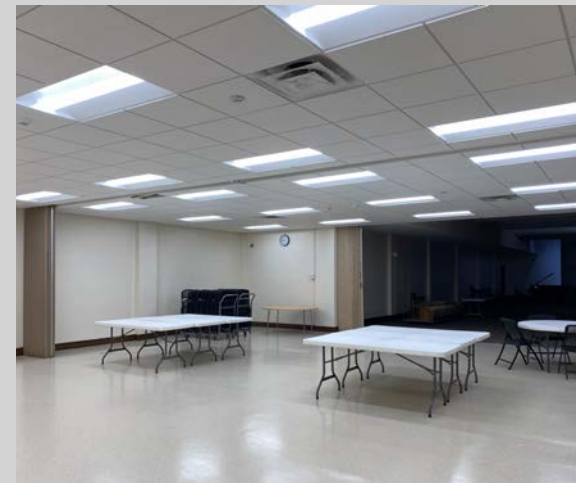
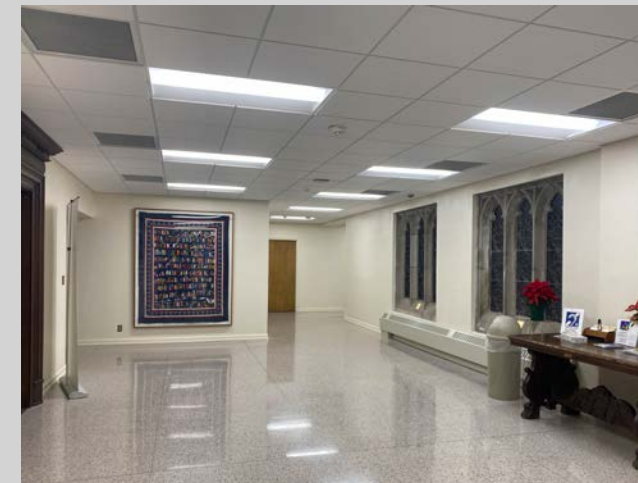
LIGHTING REPLACEMENT

- Throughout the course of the project nearly all lights throughout the facility were replaced or re-lamped with LED style fixtures or bulbs.
- Areas where the existing ceiling and lights were removed for construction purposes, the lights were replaced with new LED fixtures.
- Almost all other lights throughout the church were re-built or re-lamped to LED fixtures and bulbs. House of Hope worked with the firm LightSwitch who partners with Xcel Energy on such projects for public sector and non-profit/tax-exempt entities. After all rebates the lighting upgrades only cost the church \$2,900.
- Lighting control systems were installed in some areas of the church to meet energy code and aid with energy efficiency.

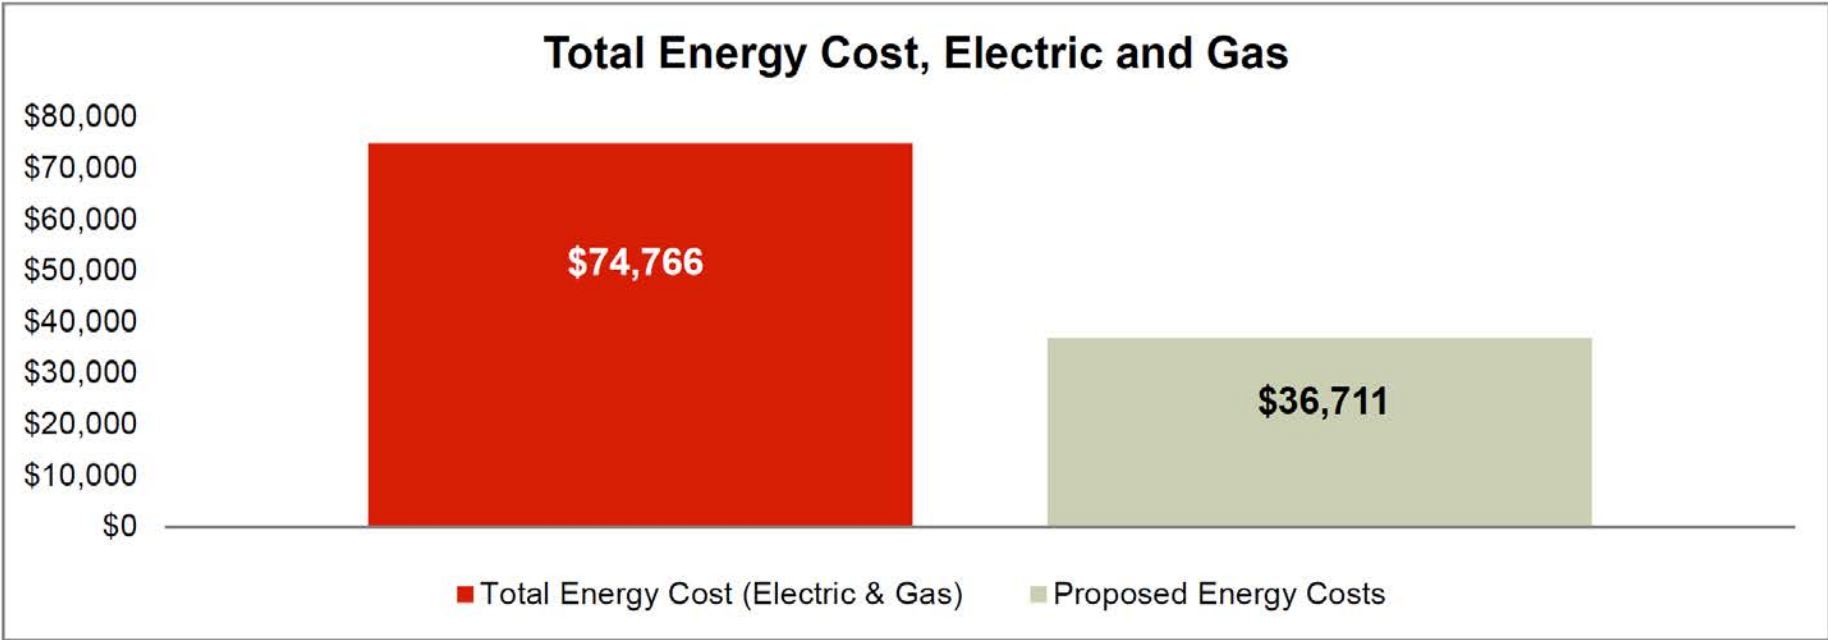
ENERGY SAVINGS PROFILE (source: Xcel Energy)

Total Energy Savings

Estimated Cost Savings, \$	50.9%
Demand Savings (kW), estimated	72.7%
Electric Usage Savings, estimated	30.6%
Gas Usage Savings, estimated	71.7%

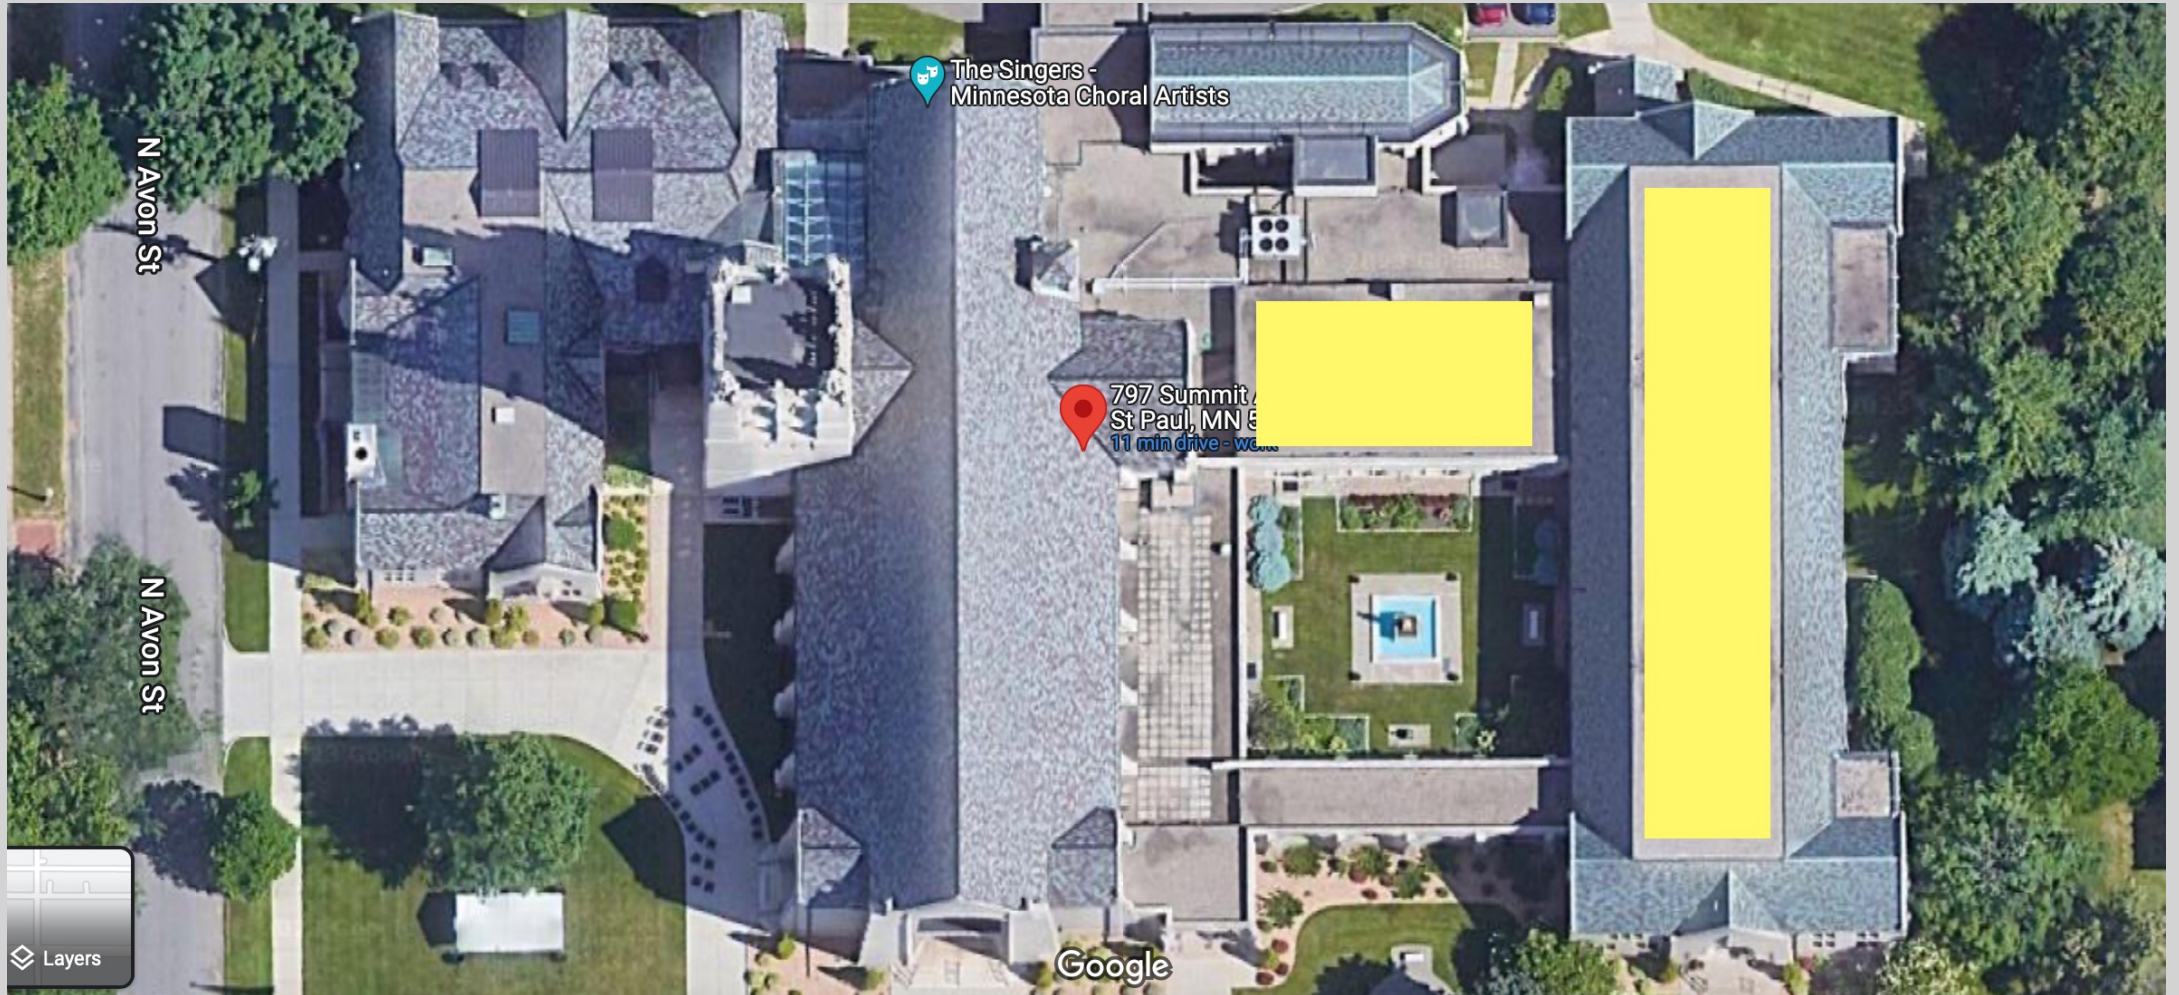
PROPOSED PHOTOVOLTAIC LOCATIONS

- House of Hope is working through the possible installation of a system with Blue Sky Electric
- Preliminary design is a 99-panel system, with estimated electrical production the first year of 50,352kWh. The estimated electrical cost savings is over \$7,000 the first year and grows to over \$14,000 a year in year 25.
- The system will produce about 25% of the church's annual electrical usage and may further increase the demand savings.
- The system has about a 9-year payback period
- The current roof structure appears to have sufficient structural capacity to support the ballasted solar panel system.
- Next steps
 - Finalize the photovoltaic system design and verify that the final design of the system does not exceed the structural capacity of the roofs
